ALLAN GARDENS

LANDSCAPE REVITALIZATION STRATEGY & MANAGEMENT PLAN

CITY OF TORONTO

TECHNICAL APPENDICES
OCTOBER 2006

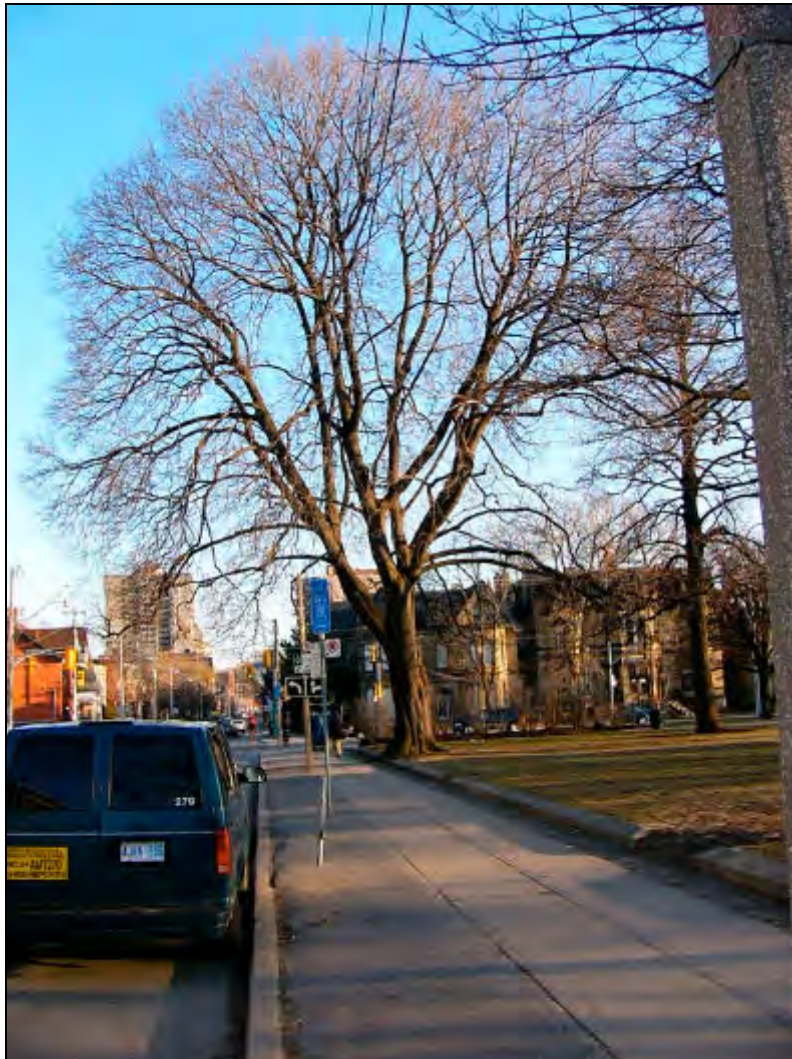
A mature tree of Norway Maple (T147) with high/moderate ratings of biological health and structural condition (April 2005).

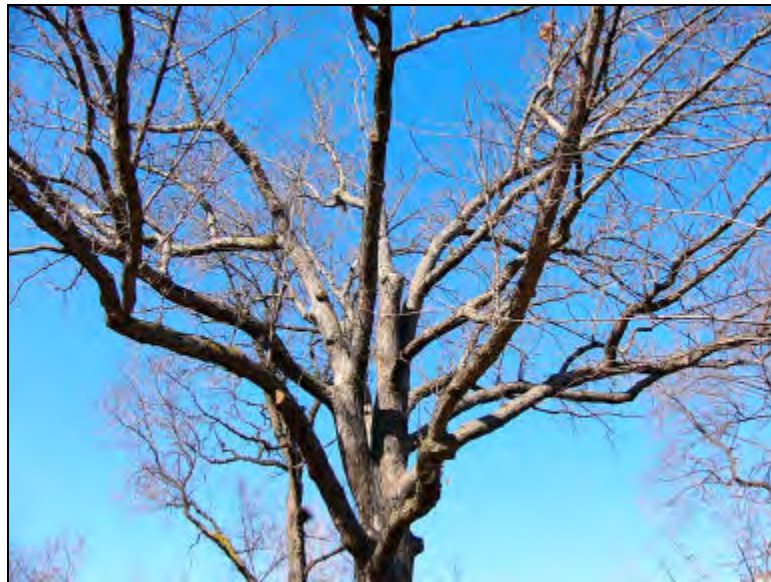
The oldest tree in Allan Gardens is this White Oak (T100). It is estimated to be between 150 and 200 years old. Past pruning and water sprouts are seen throughout the canopy (April 2005).

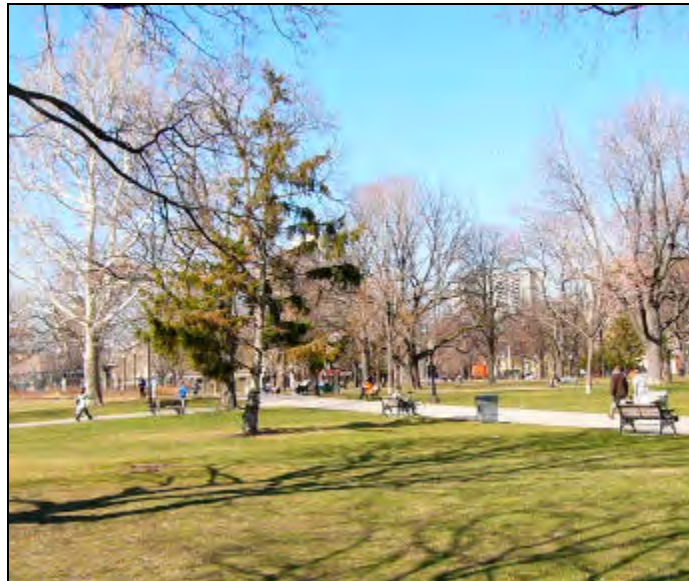
Norway Spruce (T176) with low rating of biological health based on its severely thin crown (April 2005)

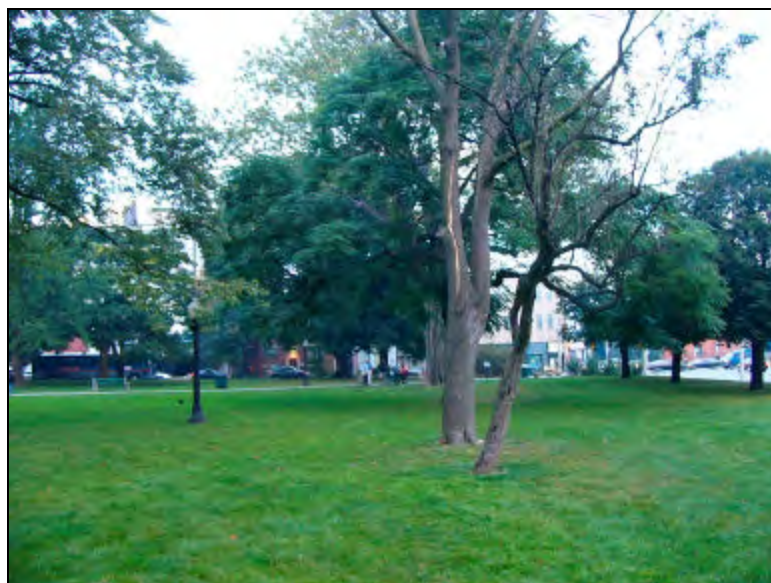
The Crab Apple (T153) in the foreground and Norway Maple (T154) both exhibit low ratings of biological health (September 2004)

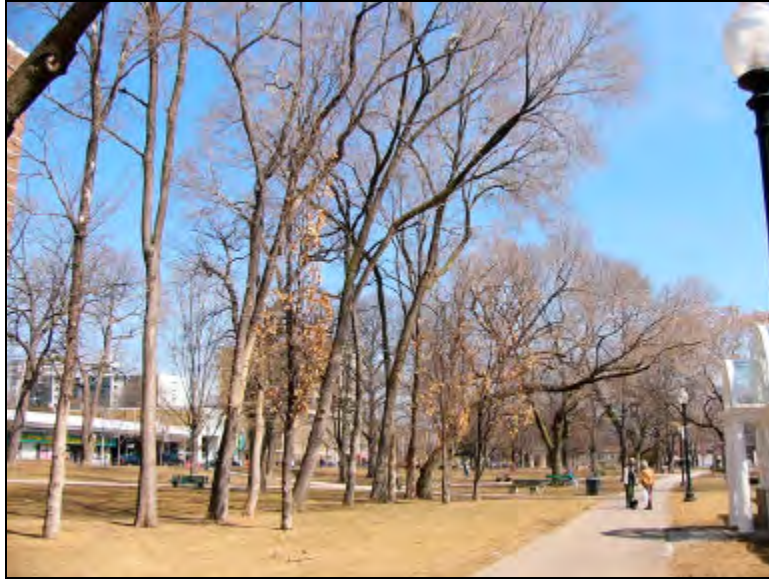
Siberian Elm (T35) in the background overhanging the walkway and north of the greenhouse has a low rating of structural condition due to a severe lean and unbalanced crown (March 2005).

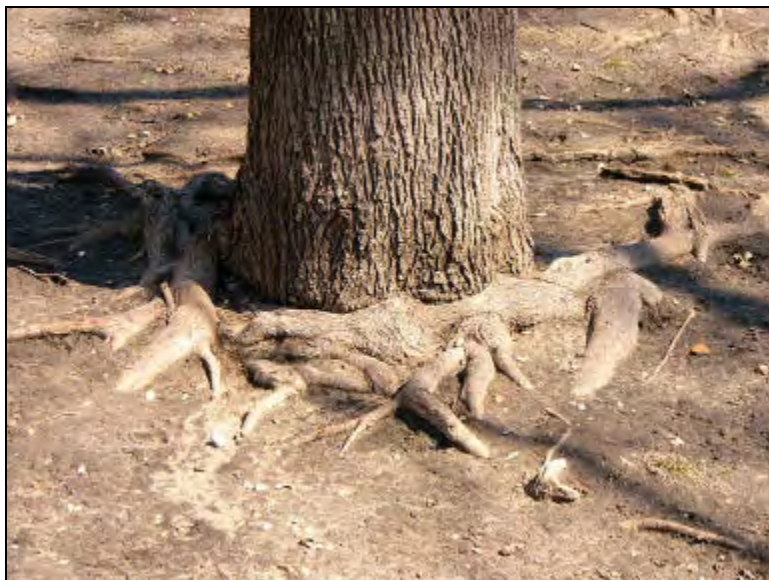
Exposed roots of this Norway Maple are girdling the tree's trunk (March 2005).

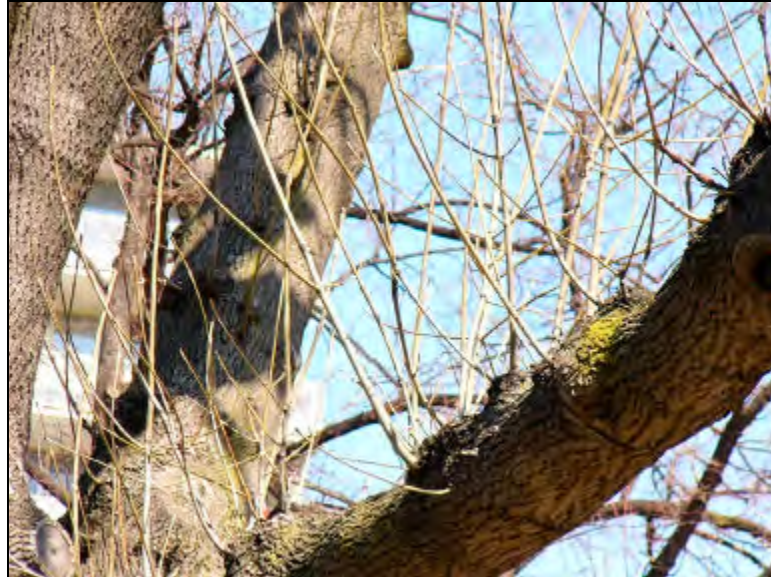
Widespread occurrences of water sprouts on branches and stems were recorded on trees throughout the Gardens (April 2005).

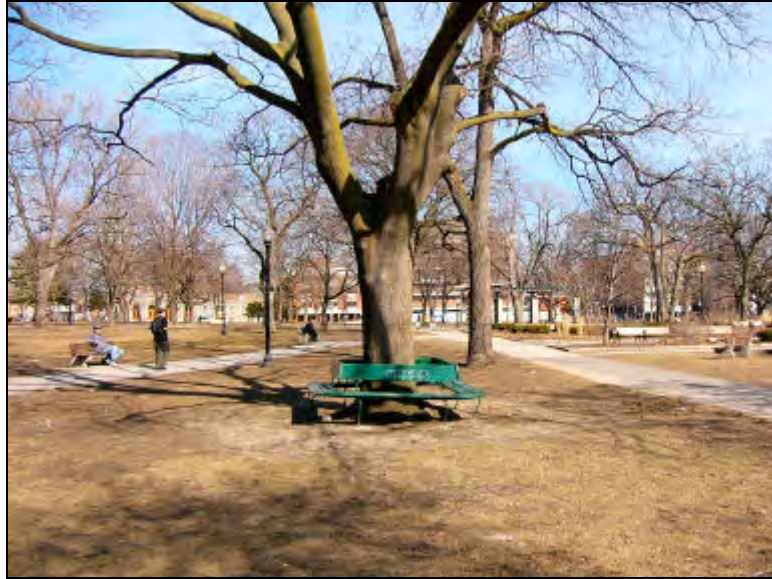
Past pruning of crowns was observed throughout the Gardens as shown on the Norway Maple (T61, top) and Scotch Elm (T231, bottom), both trees surrounded at the base by a bench.

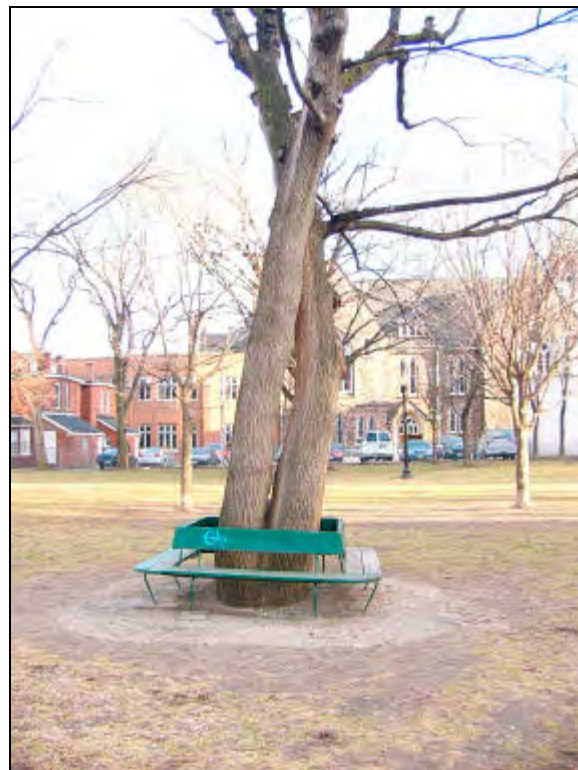
Over pruning may have contributed to stress of the trees and the widespread occurrence of water sprouts. Further information about the causes and potential mitigation of stress in trees is discussed in Section 3.2.7 Over Pruning Mature Trees.

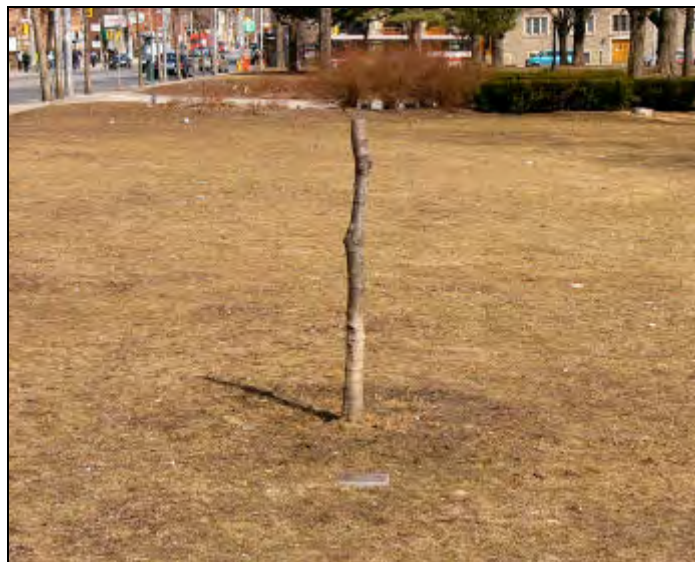
This small tree with a dedication plaque at the base had its crown broken off at the stem (March 2005).

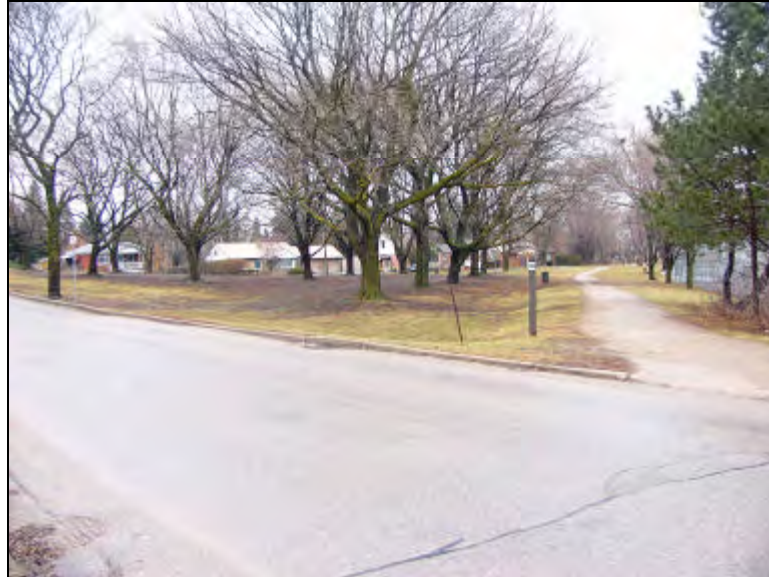
Exhibition Park in the City of Guelph. All deciduous trees are Norway maple. Muddy areas under the trees' canopies have very thin lawn grass even though park use is light (February 2006).

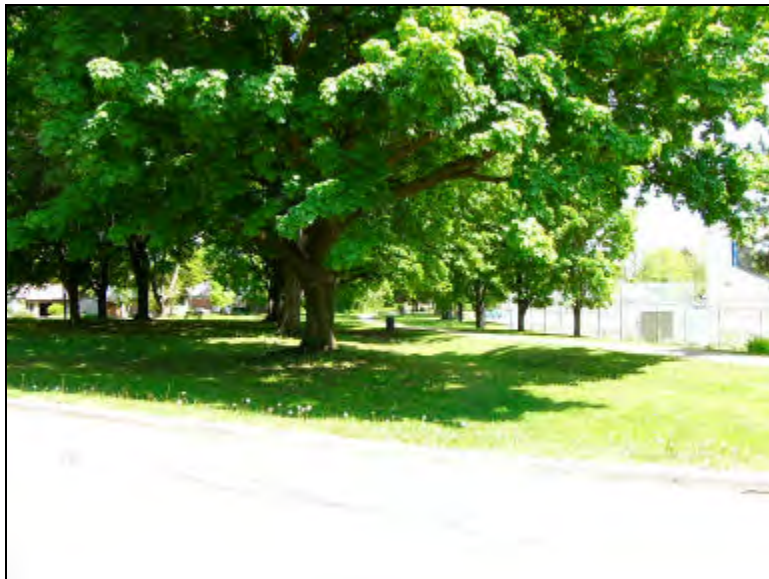
Exhibition Park at full leaf-out of Norway maple trees. Lawn grass is thin beneath tree crowns (May 2005).

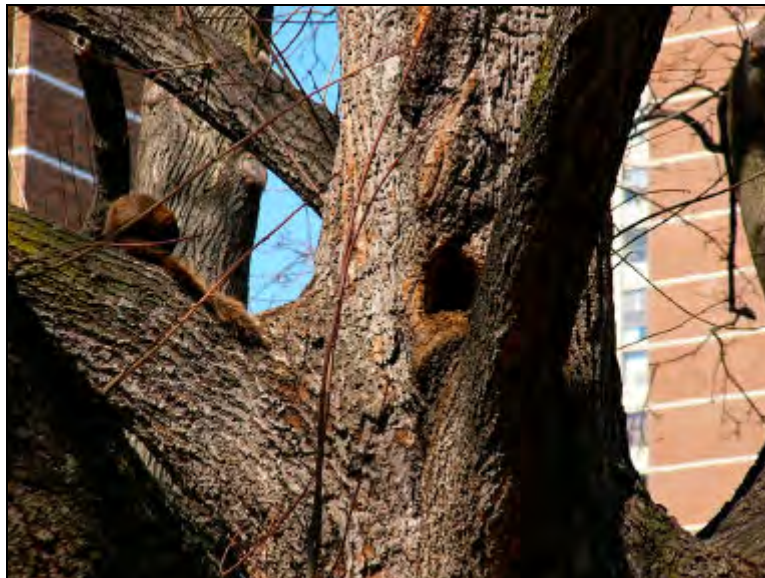
A mature Linden damaged from feeding of Yellow-bellied Sapsuckers shown as prolific series of small holes on the trunk. Water sprouts on the lateral branch are present. A gray squirrel has a den in a tree cavity (April 2005)
