ALLAN GARDENS

LANDSCAPE REVITALIZATION STRATEGY & MANAGEMENT PLAN

CITY OF TORONTO

TECHNICAL APPENDICES
OCTOBER 2006

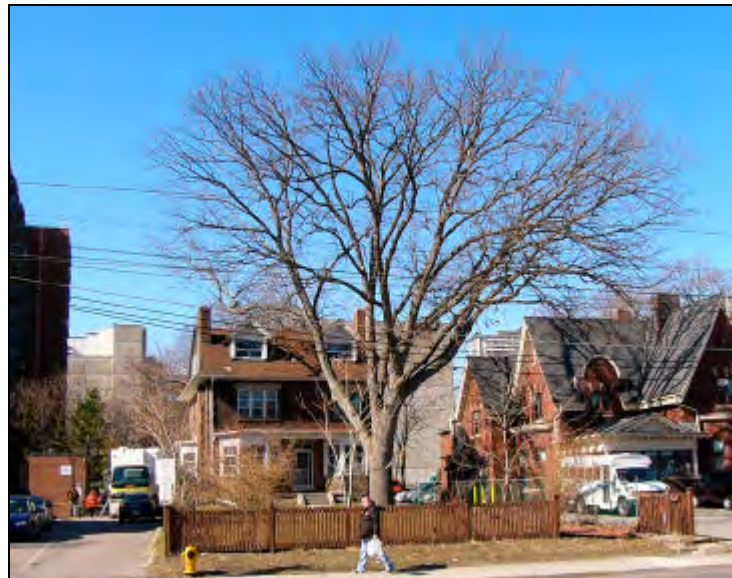
A white oak of similar size was recorded at 190 Carlton Street, within a block of Allan Gardens. Its condition is much better than T100 (April 2005).
